White Paper: Cladding Attachments Put to the Test

Abstract

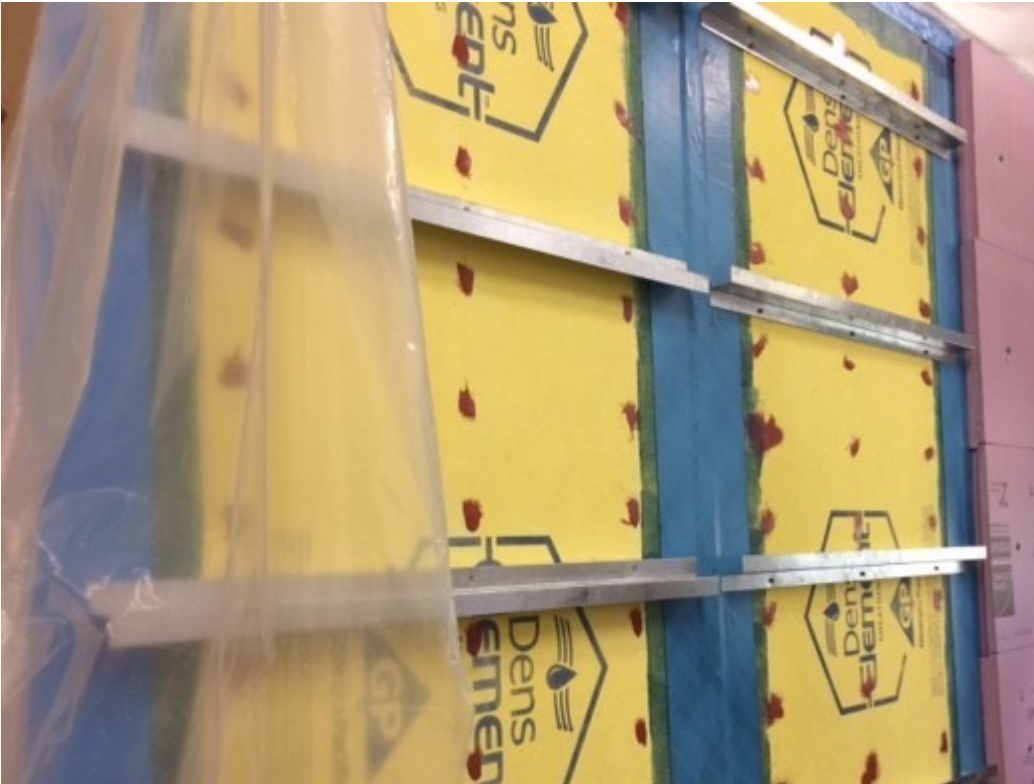
Picture 1: The DensElement™ Barrier System with Z Girts installed with flanges up and down. The Z Girts are installed both tight and spaced from the WRB. Far right test wall shows XPS attached.

For the exterior-insulated test wall, two inches of XPS rigid insulation was attached to the DensElement™ Barrier System panel using to 4 inch long self-drilling, self-tapping screws and with large (1 in. dia.) plastic cap washers. The top edge of each piece of XPS was cut with a bevel back towards the wall so some water was forced behind the insulation.

Cladding attachment clips and Z Girts were attached using two methods: a) tightly against the sheathing or WRB surface and b) spaced away from the sheathing or surface with different spacer thicknesses to allow water to flow behind the attachment.

The rigid insulation board was installed in a similar manner: with one section tight to the sheathing and two other sections spaced away from the sheathing at different spacing thicknesses to create a gap between the back of the insulation and the exterior face of the sheathing.

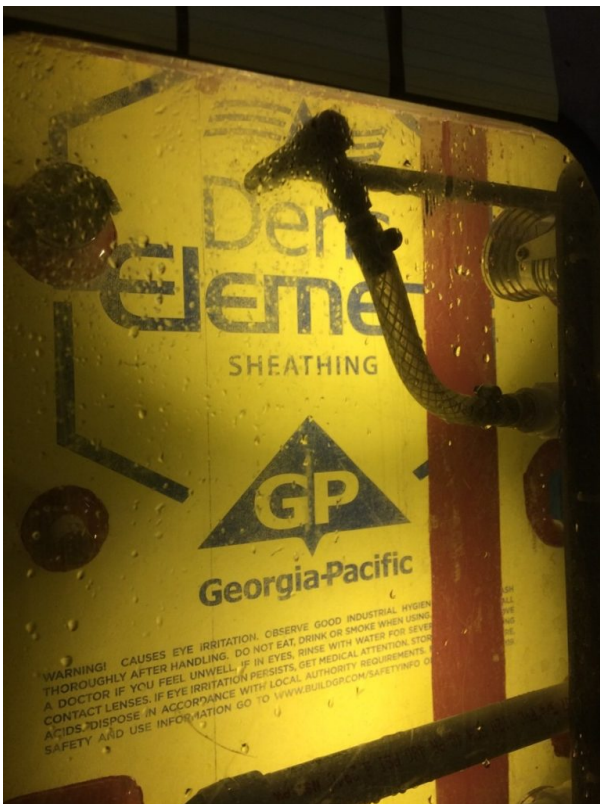
Picture: The DensElement™ Barrier System tested per ASTM E331.

The test wall and water spray nozzles were set up per ASTM E331. The walls were then subjected to water spray duration and negative air pressure loads exceeding ASTM E331 protocol for code compliance.

Water application rate was 7.5 gallons per hour per sq. ft. instead of 5.0 gallons per hour per sq. ft.

Water was applied to the surface for 60 minutes at each pressure instead of 15 minutes at the single code required pressure of 140 Pa. Instead of the total test time length being 15 minutes, it was 5 hours! The wall(s) were tested for 60 minutes each at; 0 Pa, 300 Pa, 600 Pa, 900 Pa, and 1250 Pa. The last stage is equal to sustained winds of 100 mph!
